Assessment of the Ecological Status and the Need for Renovation of Drainage Ditches in the Strumień Junikowski Catchment

Poznań University of Life Sciences, Poland

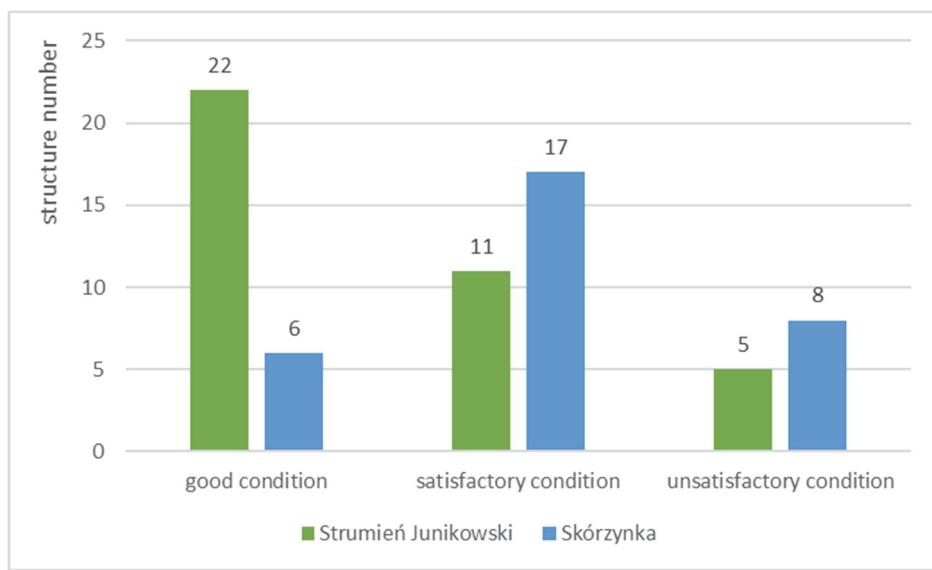
Fig. 2. Assessment of the condition of drainage structures

The field studies provided a survey of 38 concrete culverts over the entire length of the Strumień Junikowski and 31 box culverts in the Skórzynka watercourse. Their status was assessed, showing that for most structures located in the Strumień Junikowski it is good or satisfactory (Fig. 2). The greatest effect on this status was exerted by silting of the waters, which in extreme cases exceeded 30%. Another evaluated parameter was the structure headwater, which as a rule met the requirements of a good condition, i.e. over 50 cm. The primary problem for the culverts in the analysed watercourse was connected with progressing silting and overgrowing of these structures. In some of them concrete damage would also need to be repaired. During the field research it was observed that there are no small water retention devices on the watercourse. In the era of current climate changes and drought, it is extremely important to slow down the outflow. It is therefore necessary to increase the number of retention devices on the watercourse by building groundsills, barrages, sluice gates and small reservoirs. The implementation of such investments will also contribute to increasing the flood safety of urbanised catchment areas.

Field studies have shown that, in contrast to the Strumień Junikowski, the structures in the Skórzynka watercourse are in a worse condition. In 8 out of 31 culverts their condition was classified as inadmissible, i.e. not serving their function. One culvert is completely obstructed by the fallen bank openwork slabs. The parameter connected with headwater levels in the culverts was assessed as much better, as in none of the inspected structures it was classified as inadmissible. Within the administrative limits of the city of Poznań the structures are in optimal condition and they were classified as good (5 structures) and satisfactory (1 structure).

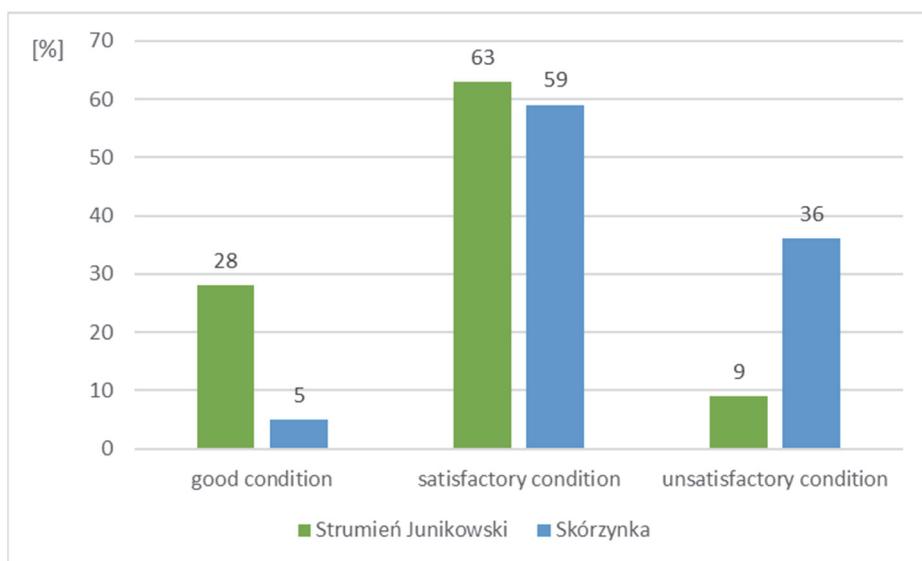
Fig. 3. Assessment of condition of linear structures

In the course of the conducted studies and field inspections the condition of linear structures was also assessed. This was based on such parameters as the mean depth of the watercourse, the degree of silting and the height of vegetation on the bottom and the escarpments. The condition of the linear structures in the Strumień Junikowski was assessed as satisfactory in over 60% of all cases (Fig. 3). Areas evaluated as being in the best condition, classified as good, included the initial segment of the watercourse, located near the airport, and the fragment at the outlet. The greatest problem observed in the Strumień Junikowski is related to the deposition of considerable amounts of rubbish and debris, particularly in the middle stretch of its course. Also numerous dead trees lying on the bottom obstruct water flow and contribute to increased silting. Over approx. 60% length of the Skórzynka watercourse its condition was assessed as satisfactory. In this case the greatest negative aspect, resulting in the deterioration of its evaluated status, is connected with the process of its vegetation overgrowth. The height of bank vegetation very often is greater than the satisfactory value and exceeds 50 cm. The relatively low flow rate in the Skórzynka watercourse contributes to accelerated ditch overgrowth. Another problem is also related with the observed high degree of silting (over 30 cm). For several years now the level of silting has not improved, as confirmed by earlier studies. Field measurements conducted in 2010 showed that the entire length of the Skórzynka watercourse is subject to observed high degree of silting with a thickness of approx. 35 cm (Przybyła et al. 2011).

4. Evaluation of the condition of drainage structures located in the Strumień Junikowski showed that they are in good condition. In contrast, the condition of the 3rd order watercourses was classified as unsatisfactory. Their immediate renovation (cleanout of silt deposits and mowing of vegetation overgrowth) are recommended.

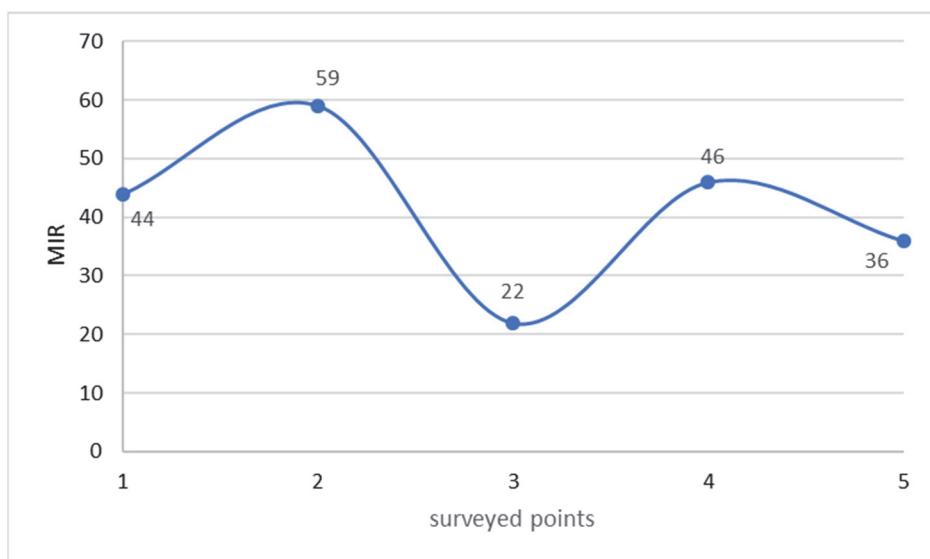
Fig. 5. Results of the Polish Macrophyte Index for Rivers in the surveyed points of the watercourse

Obtained MIR values indicate high variation in the ecological status of the Strumień Junikowski over its entire length (Fig. 5). The highest index value was recorded at Rzepińska street at the Junikowski Cemetery (point 2). This index classified waters to the very good ecological status based on the MIR boundary values for 5 classes of ecological status for lowland sandy and organic rivers. Waters in point no. 4 below the ponds were also classified as having a very good ecological status. The headwater and outlet points were found within the good ecological status according to the EU WFD. The lowest class was recorded for water flowing next to ponds in Kopanina. The recorded index classified water to the poor ecological status class.
