## **Ecological Peculiarities and Problems of Glued Timber Structures Reinforcement**

*Aleksander Chernykh\*, Stefania Mironova, Shirali Mamedov*

*Saint Petersburg State University of Architecture and Civil Engineering, Russia*

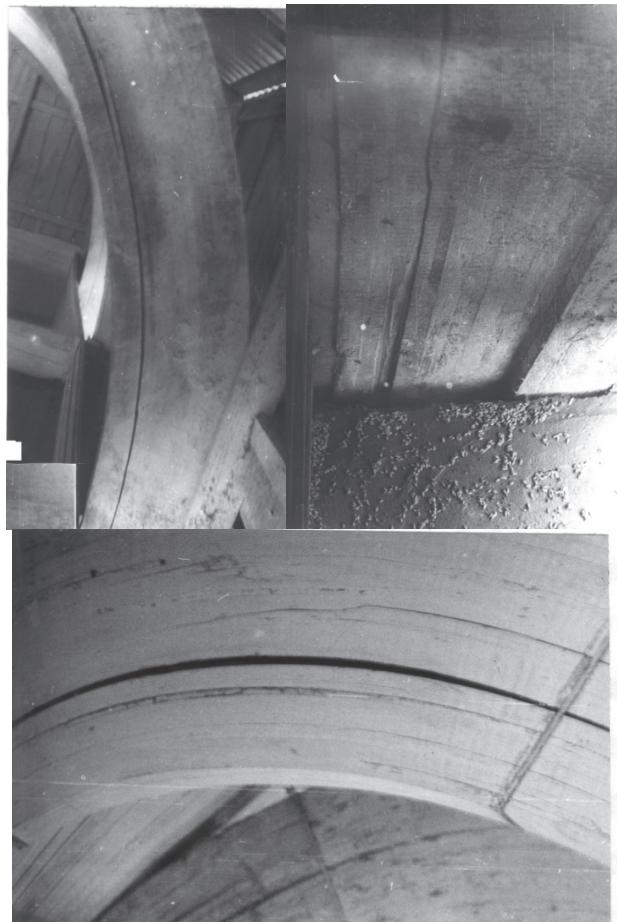
In modern GTSs with undercutting and benches already at the design stage there is the inevitability of cleavage cracks, i.e. in fact, strengthening of such structures is required even before external loads are applied. A vivid example is a bent glued frame with a ledge in the crossbar. Cracks arising in the places of such ledges can reach the support node in the column (Fig. 1). In other words, an attempt to improve these designs from a technological point of view transferred these glued laminated bent frames (GLBFs) from some of the most reliable and long-span frames to unreliable ones.

**Fig. 1.** Fragments with cracks passing in the GLBF from the ledge in the crossbar to the support

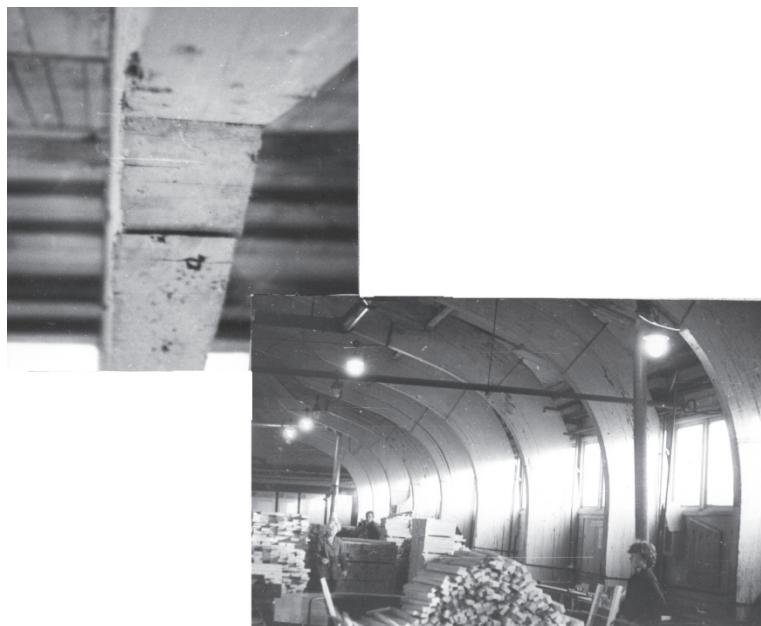
**Fig. 2.** The nature of the defects of GLBFs with a ledge in the crossbar during operation

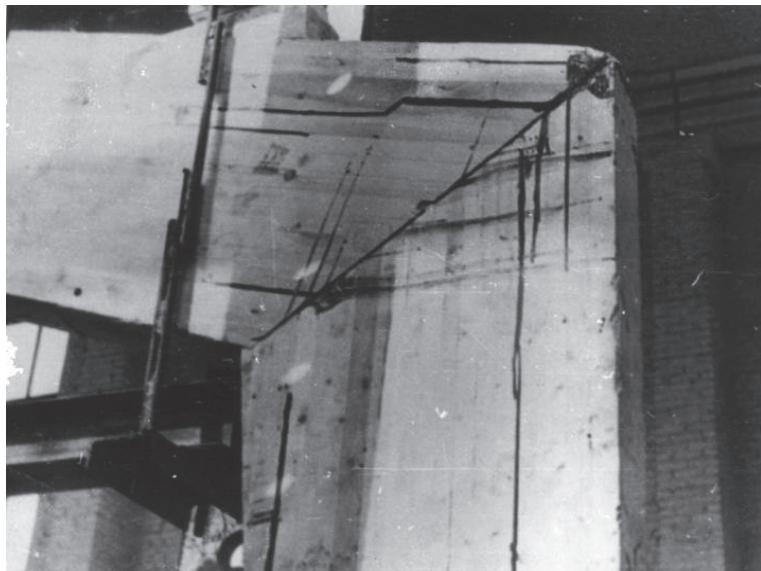
In some GTSs developed in the last decade and approved as model ones, the inevitability of the occurrence of cracks was *a priori* laid. References in publications on the poor quality of adhesives, on technological flaws did not reveal the essence of misses. Examples include MDA-type arches, glued frames of the GLBF type (Fig. 3).

**Fig. 3.** The nature of glued timber frames destruction in the stretched zone of the cornice unit with short posts

Reinforcement of glued laminated beams and other structures with cracks is recommended not only in cases where it is necessary to increase the resistance of beams to the main tensile stresses in areas located in the bearing zones, but also at the points of inflection of the glued bent beams, where glue is usually "forced" to work for tension across the fibers (Figure 3).

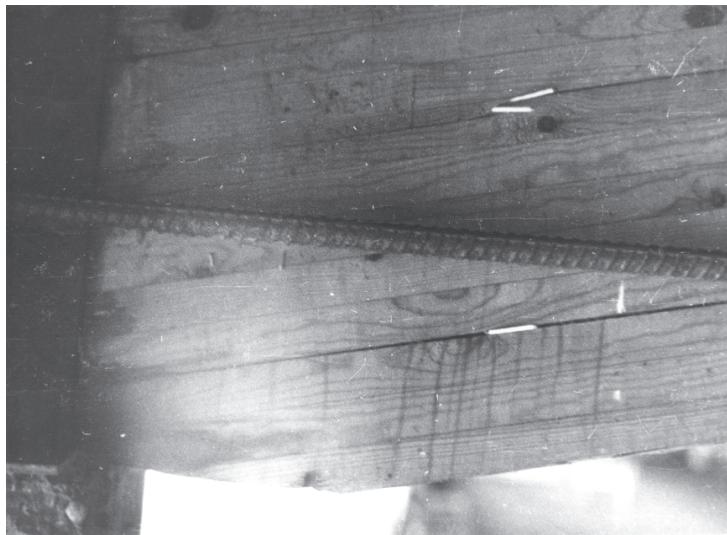
Analysis of the SSS even of standard samples leads to the conclusion that they had been cracked along main successively placed stretched areas in the form of shearing with cleavage. If we also take into account transverse forces in the MDA, from which normal stresses arise stretching the timber across the fibers (Serov 2015), then the appearance of cracks outside the stamp is inevitable (see Figure 4). Equally illiterate from the engineering point of view is the solution of the cornice unit in the glued timber frames (GTFs). In 1970, the head of the German firm, Erwin Dimter, showed the Muscovites a colorful movie about the production of frames made from rectilinear elusive elements by gluing blocks onto a toothed spike, cut through the entire section of the diagonal direction. The simplest technology attracted not only officials, but also some specialists. First, the GTFs were used in experimental construction, and after 2 years they became standard. But the SSS of broken rods turned out to be prohibitive, especially in the stretched zone. Formally, the distributive  $\alpha$  in the diagonal section of the broken rod can be represented in the form of a curved rod of GTS with a curvature radius tending to

**Fig. 4.** Cracks in the pre-support zones of glued MDA blocks (marked with matches) when the sloping section leaves the support platform

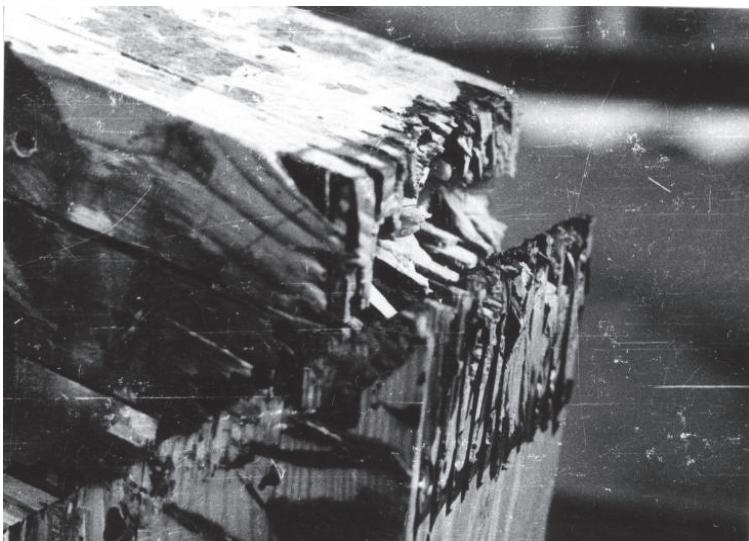
zero. Most often, such nodes are calculated according to the Henri Navier formula with the coefficients (Serov et al. 2011), which does not correspond to the actual SSS. And yet, despite the aspiration to zero  $\alpha$  in the outgoing corner of the stretched edge of the diagonal section, the cracks originate in the stretched zone and sometimes reach the support (Fig. 5a and 5b).

**Fig. 5a.** The nature of glued laminated timber frames or (GLTFs) destruction in the stretched zone of the cornice unit

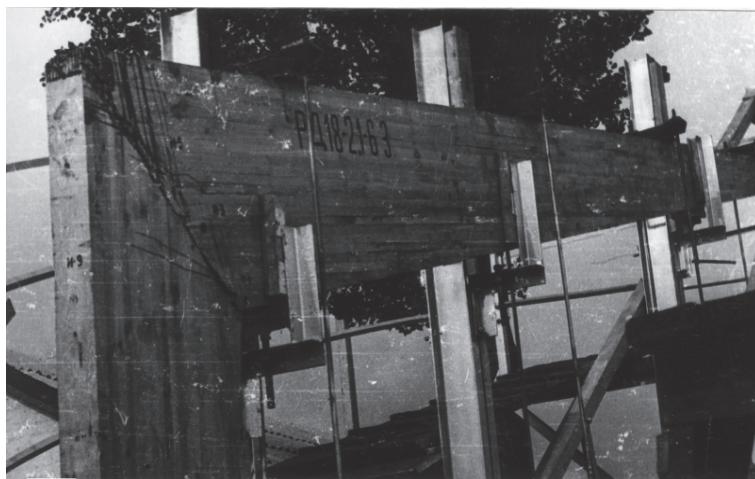
**Fig. 5b.** The nature of glued laminated timber frames or (GLTFs) destruction in the stretched zone of the cornice unit
